Systematic Approach to Boulder Stability Assessment at a Boulder Covered Area: Case Study at Gunung Bujang Melaka, Kampar, Perak

Received: 6 December 2024/Accepted: 26 May 2025

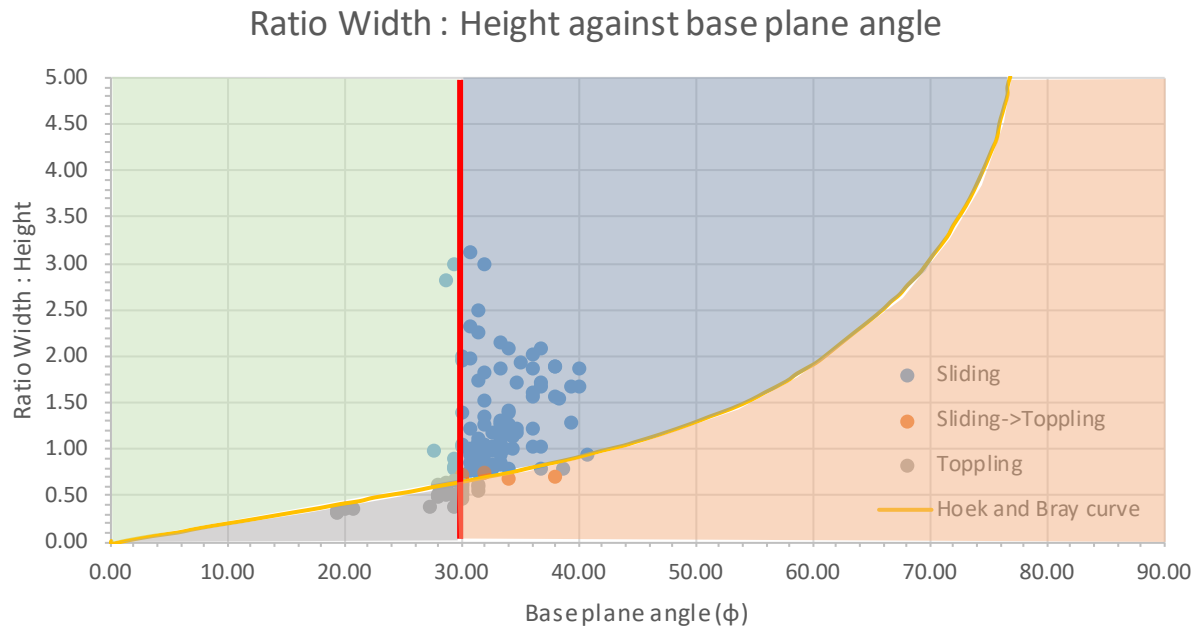
FIGURE 7. Tilt test graphical result with Hoek and Bray classification

modes (Figure 9(b)). According to Wyllie and Mah (2005), the minimum angles for sliding failure, sliding followed by toppling, and maximum toppling failure are initially similar. However, tilt test results show that the minimum angle for sliding failure is 28°, with a width-to-height (W:H) ratio of 1. For sliding followed by toppling, the minimum angle is 30°, with W:H ratios ranging from 0.63 to 0.72. The maximum toppling failure angle is 32°, with W:H ratios ranging from 0.54 to 0.61. To simplify the use of the graph, these three angles were

averaged, resulting in a value of 30° , represented by the red line. The Hoek and Bray curve (Wyllie & Mah 2005) fit well with the plotted data.

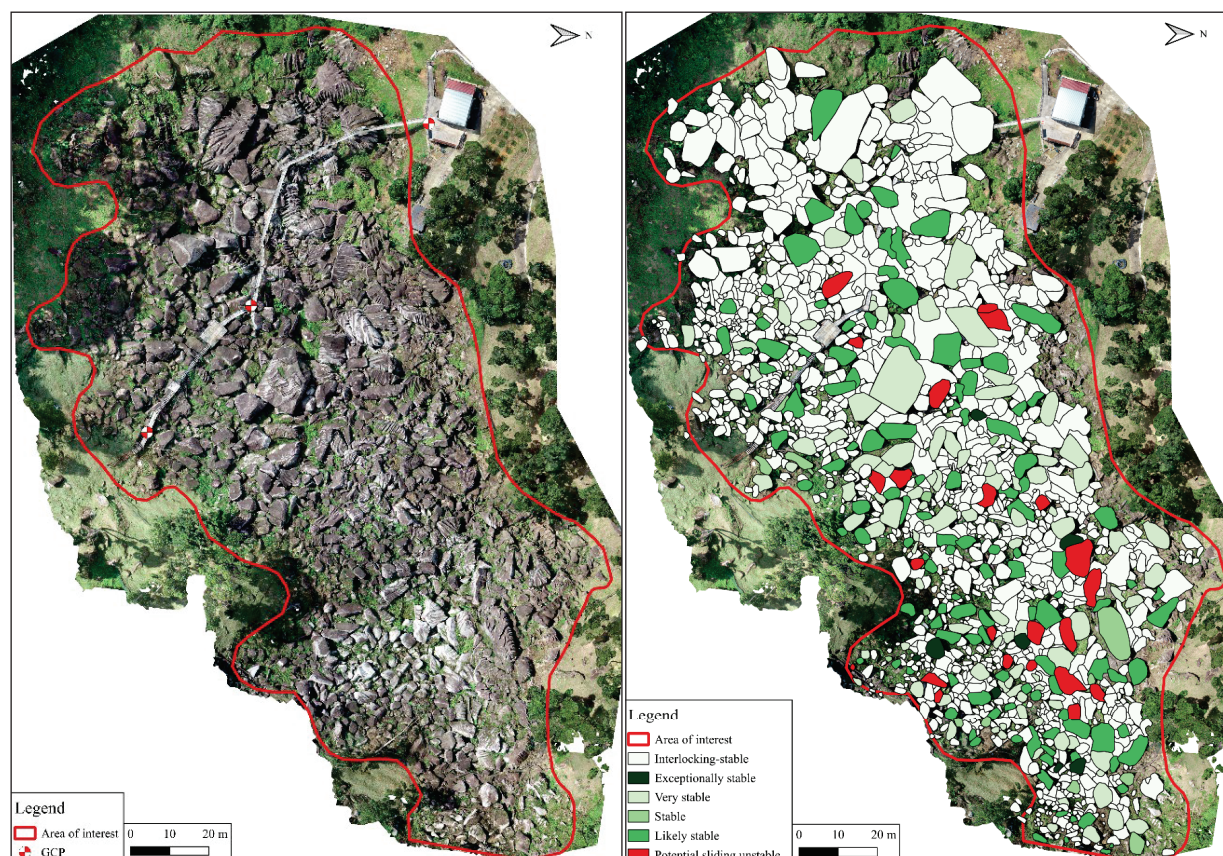
FIGURE 8. a) Orthomosaic image of project area and b) Geohazard map of the project area

Figure 8(a) shows the orthomosaic of the project area, generated using ShapeMetrix. The total area of interest is 17,197.4 m² (equivalent to 4.25 acres), containing 1,604 boulders. A statistical analysis using GIS showed that the areas of individual boulders range from 0.19 m² to 167.6 m², with a mean value of 2.85 m². The first quartile is 1.85 m², the third quartile is 8.34 m², and the interquartile range is 6.49 m².

The assumption that boulders meeting the criteria such as deep-seated, with lateral support by adjacent boulders, and base-invisible are considered interlocking-stable was combined with kinematic analysis and the Hoek & Bray method to produce a geohazard map of the project area (Figure 8(b)). The map shows a few potential failure boulders randomly distributed across the site, covering only 1.4% of the total area (241 m^2 , or 0.06 acres) and only sliding potential (SL) is identified across the boulders. Table 2 summarized the potential failure boulder based on their characteristic.

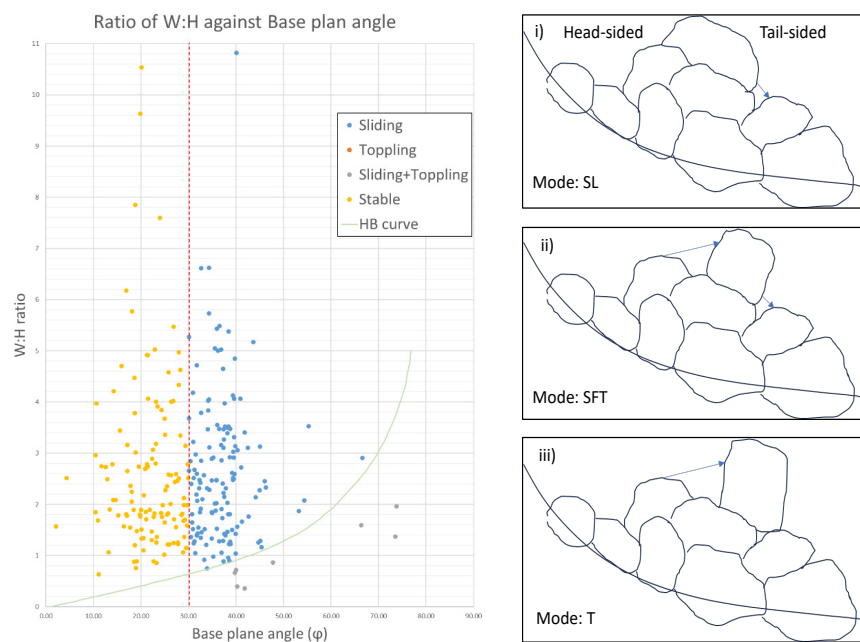
FIGURE 9. a) Graphical result of boulder's mode of failure based on Hoek and Bray classification and b) Schematic diagrams of mitigation on different modes of failure (arrow pointing upward represents anchor while arrow pointing downward represent brace)

Using this approach, the failure mode of each eligible boulder was determined based on its base angle and W:H ratio (Figure 9). Out of the 274 boulders analyzed, 125 were classified as stable, 141 showed potential for sliding, 8 had potential for sliding followed by toppling, and none exhibited pure toppling potential. A boulder is considered high risk of sliding or sliding followed by toppling if its base plane angle exceeds 66° . In this study, 1 boulder was identified as having a high risk of sliding, and 3 boulders were classified as having a high risk of sliding followed by toppling.

The overall stability of the study area is deemed adequate, with only a small number of boulders requiring mitigation. Given the scattered nature of problematic boulders, avoidance is a feasible strategy for future development. However, mitigation measures such as anchors or braces should be implemented for boulders at risk of failure to enhance their stability. The placement of these supports is crucial and depends on the mode of failure (Figure 9(b)).

For sliding boulders (SL), braces should be positioned at the tail to provide additional lateral support to the base. For toppling boulders (T), anchors should be placed at the head to counteract the toppling force. For sliding followed by toppling (SFT), braces should be located at the tail to prevent sliding, while anchors should be placed at the head to pull back the boulder and prevent toppling. Both tail-bracing and head-anchoring work together to form a larger, pseudo boulder with enhanced base support.
