Effect of High-speed Parameters on Uncoated Carbide Tool in Finish Turning Titanium Ti-6Al-4V ELI

M.A. SULAIMAN, C.H. CHE HARON*, J.A. GHANI & M.S. KASIM

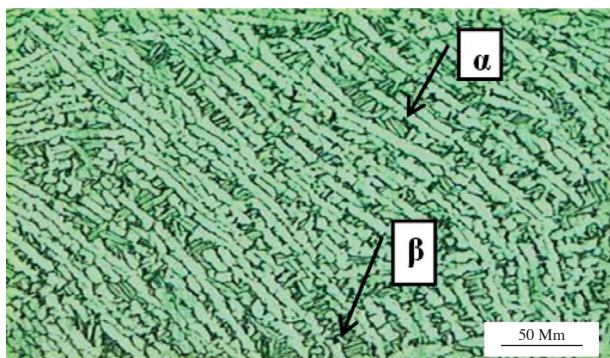
FIGURE 1. Microstructure of Ti-6Al-4V ELI

The workpiece material used in the experiments was a cylinder bar of an alpha-beta titanium alloy Ti-6Al-4V ELI, which is equiaxed at the α phase and surrounded by β in the grain boundary, as shown in Figure 1. The nominal compositions of the alloys in weight % include; 6.1 wt. % Al, 0.08 wt. % C, 0.22 wt. % Fe, 0.0031 wt. % H, 0.006 wt. % N, 0.12 wt. % O, 0.003 wt. % S, 0.03 wt. % Si, 3.8 wt. % V, 0.005 wt. % Y and Ti balance. The workpiece has a microstructure, which consisted of elongated alpha phase surround by fine, dark etching of beta matrix. This material possesses high strength and depth-hardened ability (317

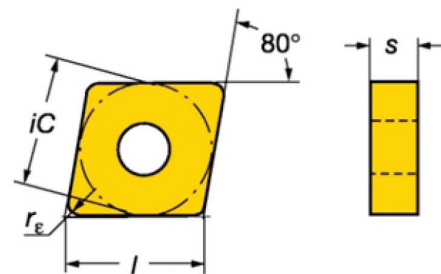
FIGURE 2. Schematic geometry of the insert used in the machining

A type of carbide insert with International Standards Organisations (ISO) designation CNGG 120408-SGF-H13A was used for the machining experiments. The cutting tool used was a straight tungsten carbide tool, which was an uncoated rhombic-shape, throw-away type with chip breaker. The insert consisted of 82.6 wt. % tungsten carbide, Wc with 16.4 wt. % of cobalt, Co as binder. Straight tungsten carbide (WC/Co) cutting tools have proven their superiority in almost all machining processes of titanium alloys (Ezugwu et al. 2003). The schematic geometry of the insert is shown in Figure 2.

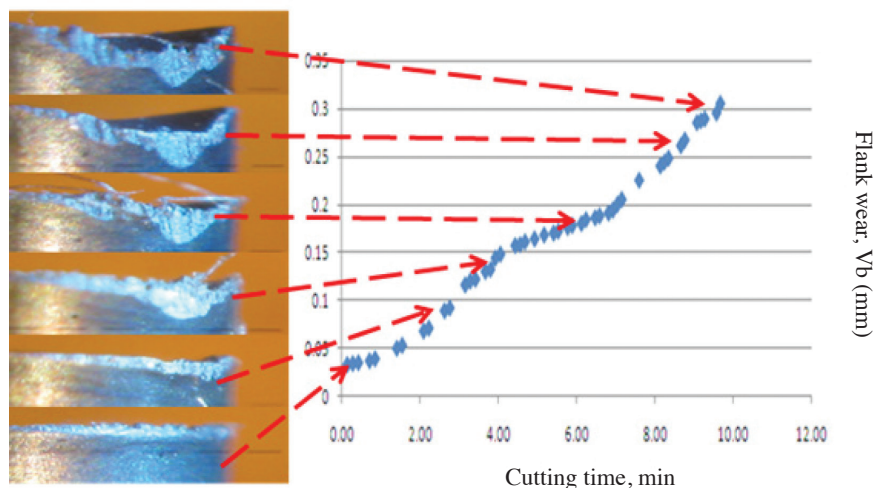
FIGURE 3. Flank wear-land, Vb (mm) vs. cutting time, (min)

The discussion of the results are focused on the tool-wear behavior during high-speed turning of titanium alloy Ti-6Al-4V ELI. The results showed that flank wear increased with increase in cutting speed, in which the wear progressed more quickly at the highest cutting speed of 220 m/min, followed by the cutting speeds of 170 and 120 m/min. The flank wear-land versus cutting time in turning Ti-6Al-4V ELI using uncoated carbide tools is shown in Figure 3. A typical three-stage pattern of tool wear is shown, similar to the pattern reported by Jawaid et al. (1999) when titanium alloy was machined using coated and uncoated carbide tools. The wear occurred rapidly during the initial stage, gradually increased in the

second stage and greatly increased at the final stage. The rapid increase at the initial stage was due to a small contact area between the cutting tool and the workpiece, which caused an increase in temperature at the cutting edge and some material were easily removed from the cutting tool (Che Haron et al. 2001; Gusri 2008). The cutting edge of an insert is subjected to a combination of high stress and high temperatures, which cause tool wear due to one or several mechanisms (Che Haron 2001). These mechanisms depend on cutting geometry, tool and workpiece material combinations and thermal loadings encountered.

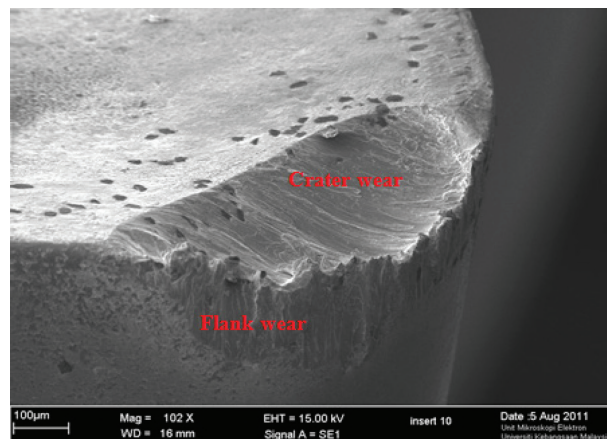
FIGURE 4. SEM micrograph (scale 100 μm) shows the flank and crater wear on CNGG 120408-SGF-H13A

normally below 90 m/min. Figure 4 shows the domain two types of wear on the cutting edge obtained using SEM technique (crater and flank wear) when machining titanium alloy. Flank face wear is caused by friction between the newly machined workpiece surface and the contact area at the tool flank. Based on smooth wear patterns on the flank face of the tested tool, the dissolution-diffusion wear mechanism is seen to be more predominant compared with other mechanisms, especially in high-speed cutting. On the other hand, crater wear normally occur at the tool-chip contact area (tool top surface) where the tool chip moves with friction force. A crater can also be formed by shearing on the rake face. The rake wear on the tool were resulted from dissolution-diffusion machining in high speed turning titanium alloy. Here higher temperature provided an environment for tool material atoms to diffuse beyond tool-workpiece interface, similar with previous research where the chip pulling apart a portion of the rake face in chip flow direction (Narutaki & Yamane 1993). In addition, the dissolution-diffusion wear predominated on the rake face of all the uncoated carbide (Dearnley 1986).

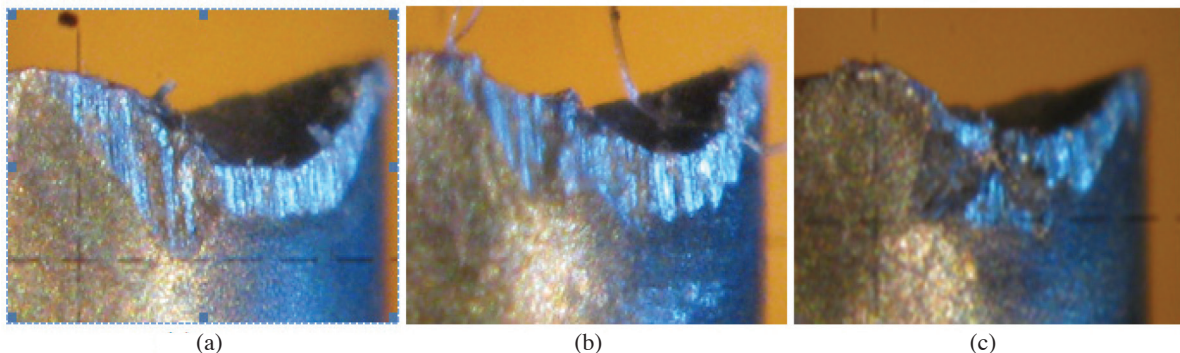
FIGURE 5. Flank wear land, V_b were measured by 3D microscope Perthometer for: (a) $V = 220$ m/min, (b) $V = 170$ m/min and (c) $V = 120$ m/min

Figure 5 shows the final stage of flank wear-land pictures captured by a digital camera during measurement

by 3D microscope Perthometer. The chipping occurred at the cutting edge because of the heat generated during the high-speed cutting of titanium alloys. Additionally, higher stresses caused the chipping process on that area and abrasion process occurred at some other places.

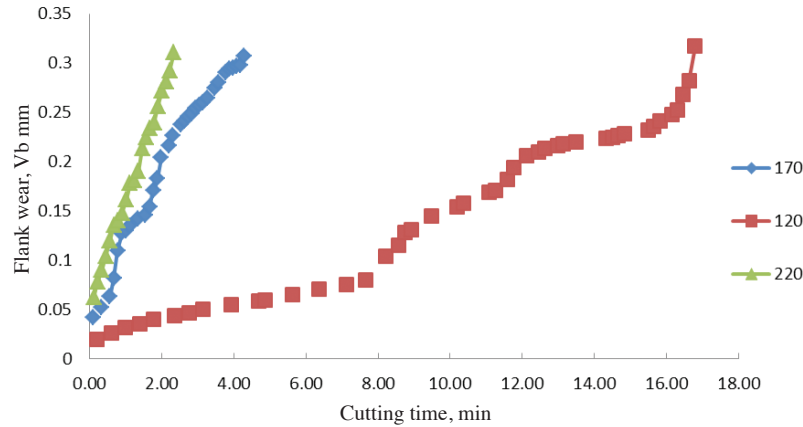
FIGURE 6. Cutting time, min for various cutting speeds (m/min) on tested inserts

The results from the machining experiment showed that the flank wear, rake wear and tool life were affected significantly by the cutting speed. Increase in cutting speed caused a large increase in cutting temperature at the cutting edge of the tools. The higher temperature generated caused the tools to lose their strength and plastic deformation occurred. Figure 6 and Table 2 show that the tool life for the highest cutting speed of 220 m/min is very short (2.34 min), followed by 170 m/min with 4.29 min and the lowest cutting speed of 120 m/min with approximately 16.79 min. However, according to ISO 3685, the tool life more than 2 min is an accepted value for machining an expensive material. Therefore, these tool life values are considered suitable for machining titanium alloy Ti-6Al-4V ELI. These cutting parameters and tool life values are presented in Table 2.

Based on the experiment, the wear progression of uncoated carbide tools occurred generally in three stages: Initial stage, gradual stage and abrupt stage of wear. In this work, the width of flank wear-land, Vb_{avg} was set at 0.3 mm in reference to ISO 3685. The average flank wear, Vb_{avg} can be used as a factor in determining the tool life of all tested inserts. According to the graph, the cutting tool rapidly wears down with the increase in cutting speed, also related to the tool-life data. The uncoated carbide tool can be used in high-speed cutting of titanium alloy Ti-6Al-4V ELI but only in flooded condition. The cutting speed of 220 m/min was considered as the upper limit for uncoated carbide tool to finish turning titanium alloy because tool life at this speed is approximately 2.3 min.
