Information for the Malaysian Asphalt Industry towards Better Pavement Interlayer Bonding

ABSTRACT

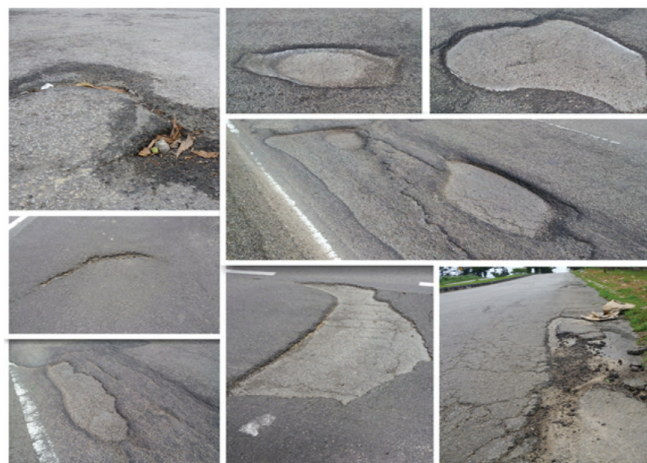
FIGURE 1. Collection of photos on pavement distresses encountered in Malaysian pavement due to poor adhesion, which includes of slippage, delamination and formation of shallow potholes

continuous acceleration and deceleration, slippage failures may be frequently encountered as well (Romanoschi & Metcalf 2001). Besides, delamination of surface layer also seems to be a distress related to poor pavement interlayer bonding (Santucci 2009). Several real cases incorporating the problems related to poor bonding have been reported by researchers worldwide (Charmot et al. 2005; Chen 2010; Pavement Interactive 2008). Computer analysis conducted by King and May (2003) and Roffe and Chaignon (2002) after West et al. (2005) also agreed that pavement service life is significantly reduced when the bonding is insufficient. Due to that, maintenance work usually approached earlier. Delamination and potholes can be considered as one of the most common types of pavement distress related to poor bonding in Malaysia, though slippage failure can be occasionally found. Figure 1 depicts some of the pavement distresses encountered in Malaysia due to insufficient pavement bond.

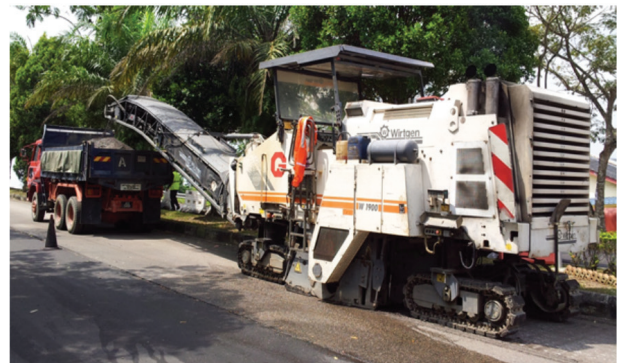
FIGURE 2. Wirtgen milling machine W1900 used by the contractors to perform milling operation

A resurfacing work in Johor Bahru area involved a dual lane road with approximately 1.5 km length. As usual, the road section is milled, by using Wirtgen milling machine W1900 as shown in Figure 2. Milling depth is about 50 mm. As milling involved removing of pavement surfacing materials, it is unavoidable to leave behind on the pavement with dust and loose material after the process which is certainly harmful to proper bond development (Jeevan 2007; McGhee & Clark 2009; OHIO 2003). This has become the major concern for milled pavement and for that, the contractor used a power broom to clean the milled section thoroughly, minimizing the effect of dust from milling as shown in Figure 3. Meanwhile, for unmill pavement, pavement surface cleaning is also needed to remove organic or inorganic matters which is encountered during construction. This agrees to Caltrans (2009) and Hansen (2008) which suggested that tack coat should be applied on dry and clean surfaces which is cleaned by means like power broom, vacuum sweep or high pressure flush, depending on the surface condition for which cleaning method is to be applied. Santucci (2009) has an

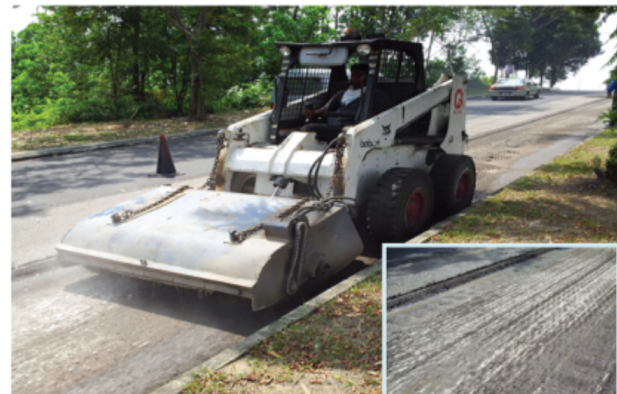
FIGURE 3. Milled pavement is cleaned by mechanical power broom to remove the dust left behind on the pavement. Small figure at the bottom right corner shows the texture of the milling

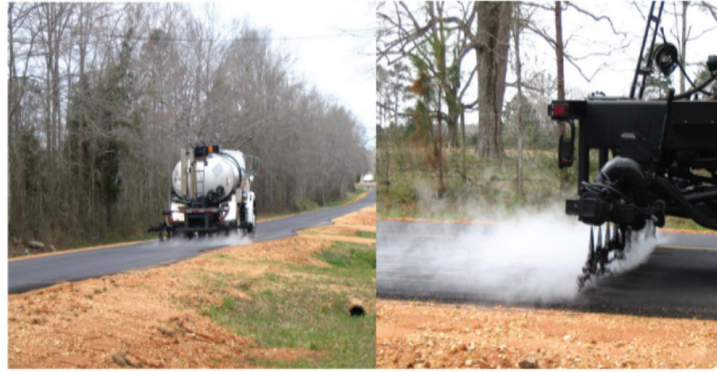
FIGURE 4. A view of asphalt distributor truck performing the tack coat application on a road section to be paved (West et al. 2005)

as early as 1980's to apply tack coat or prime coat. Figure 4 shows the application of tack coat using an asphalt distributor truck. One major advantage of using the asphalt distributor truck is to provide a more uniformly distributed tack coat on a surface to be paved, which ensure the curing rate of asphalt emulsion for the entire pavement to be constant besides having a faster operation time and capable to adjust the target spread rate of tack coat. As in Malaysia, the typical method of applying tack coat is still by using hand wand sprayer as shown in Figure 5, which is generally time consuming and normally ended up with non-uniform spread of tack coat. Tack coat distributor truck does exist, but its use is only limited to large scale project. Application of tack coat by both methods certainly resulted in different spraying quality, in which asphalt distributor truck will definitely provide a better spraying quality. This is simply due to the fact that the asphalt distributor truck consider a variety of significant factors which may affect the spraying of tack coat like spray bar height, nozzle angle of the spray bar, sufficient pressure to force the tack coat through the spray bar and the truck speed itself while spraying the tack coat. All these factors are well discussed with attached figures by OHIO (2003) and Caltrans (2009). Another concern for tack coat application using hand wand sprayer is the consistency of the tack coat application rate as specified by JKR (2008). If such method of tack coat application remains, the specification will serve no purpose since it is rather impossible to accurately calibrate the desired application rate using the hand wand sprayer (West et al. 2005). Even worst, non-uniform application will certainly be a norm to this method, resulted in formation of ponding of tack coat at a certain location as shown in Figure 6, thus affecting the curing rate of asphalt emulsion and provide the slipping plane between the layers due to excessive application. Such construction quality may explain the frequency of delamination distresses to occur so rapidly in the country.

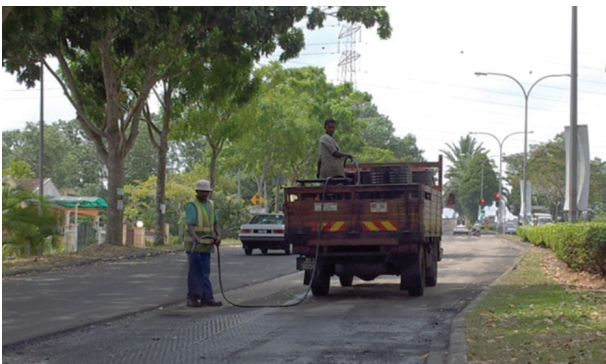
FIGURE 5. Asphalt emulsion tack coat application using hand wand sprayer in Malaysian road construction

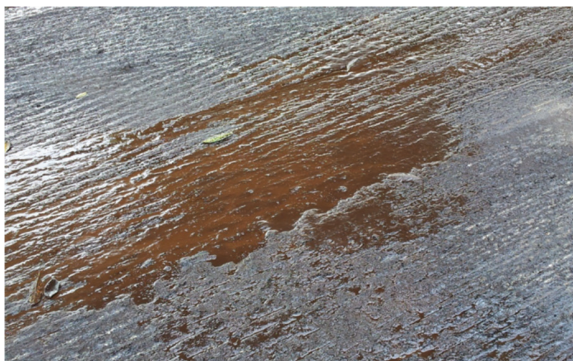
FIGURE 6. Ponding of asphalt emulsion tack coat at certain location on a pavement. Excessive application of the tack coat initiates the slipping plane for which distresses like delamination and slippage failure to occur

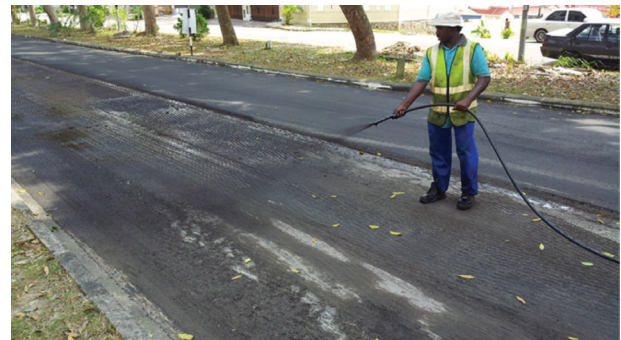
FIGURE 7. Typical poor construction quality due to insufficient knowledge related to pavement bonding. Pavement surface remains wet after milling operation during the tack coat application. Clearly visible also the existence of organic matters (leaves) which can hinders the bond development between pavement layers
